The
San Francisco Earthquake and Fire

A BRIEF HISTORY OF THE DISASTER

A Presentation of Facts and Resulting Phenomena, with Special
Reference to the Efficiency of Building Materials
Lessons of the Disaster

A. L. A. HIMMELWRIGHT, C.E.

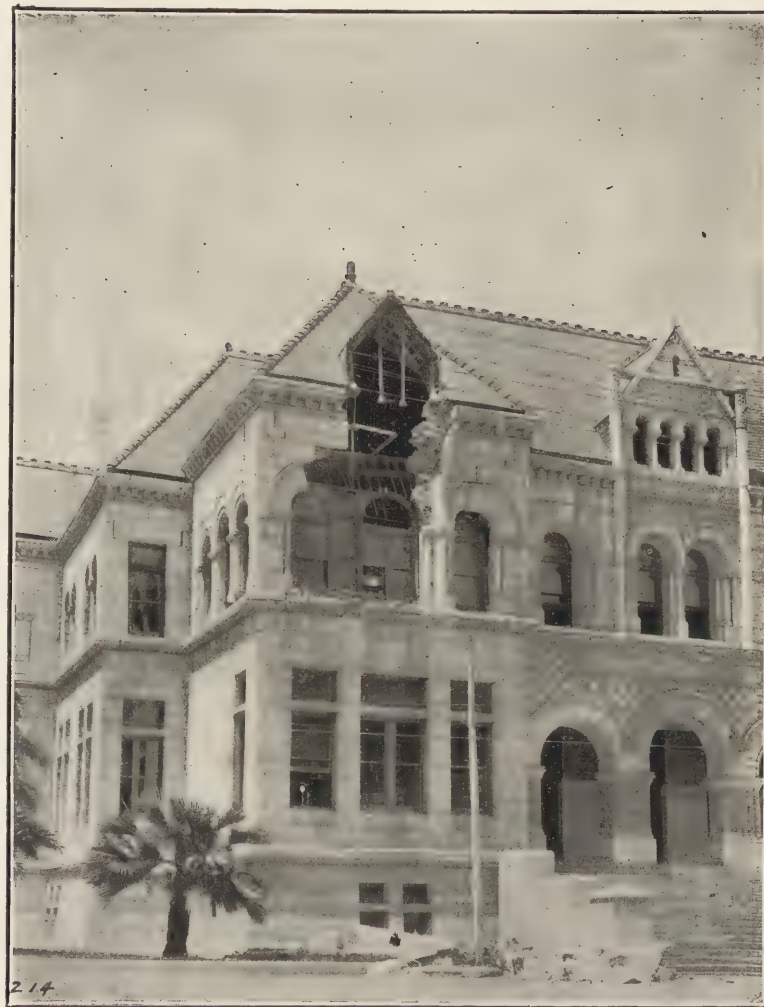
HALL OF RECORDS. San José. Showing a section of stonework and brick backing that was shaken out of one of the dormer windows by the earthquake.

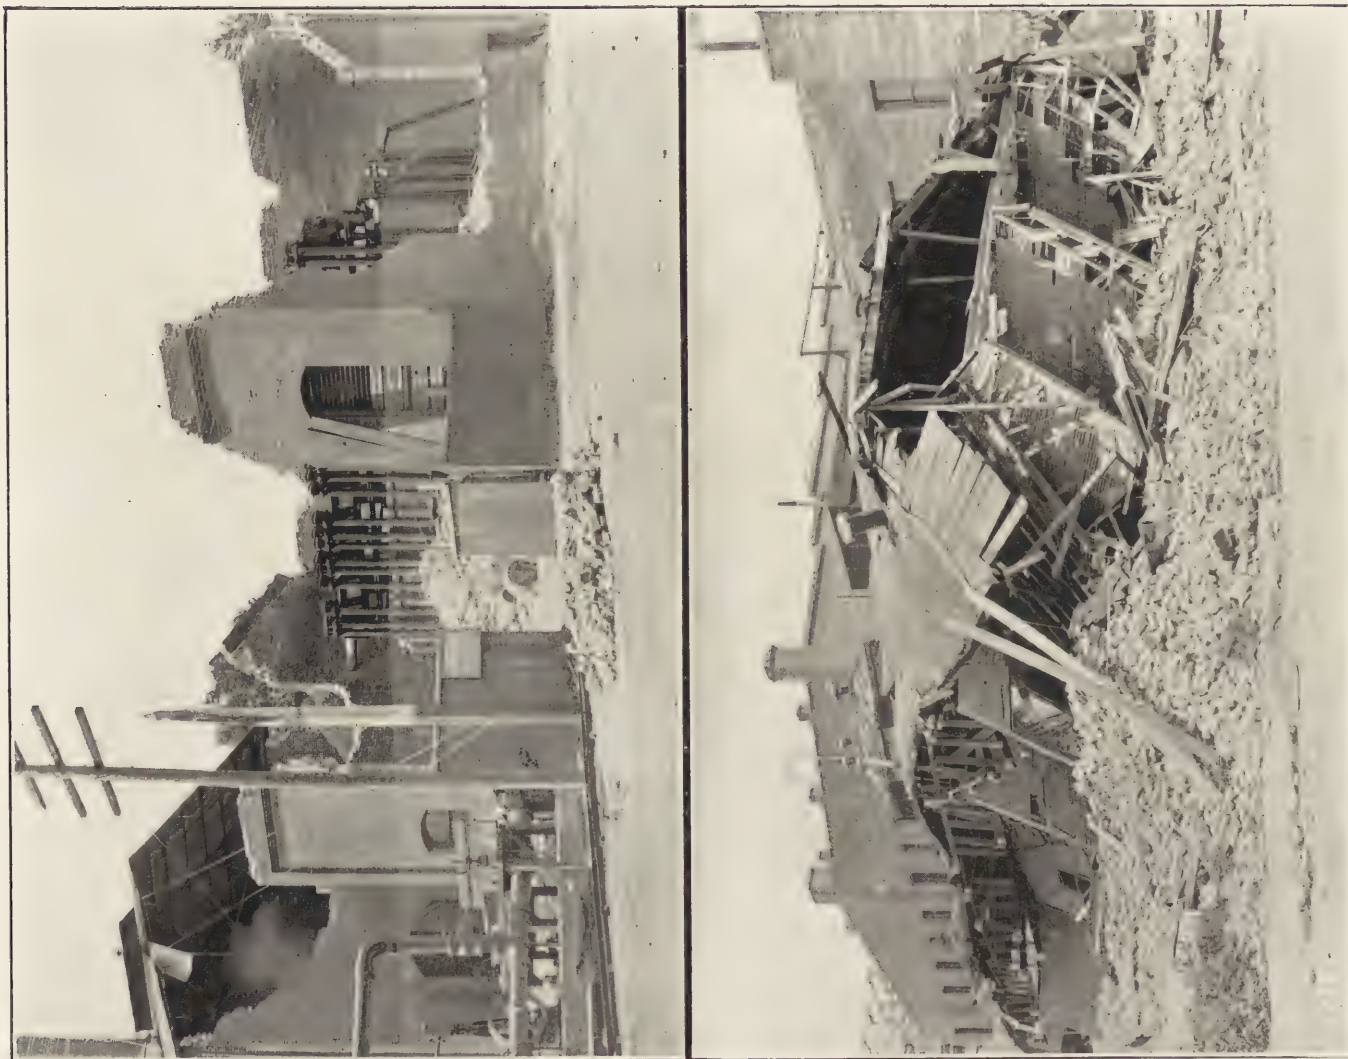
EARTHQUAKE DAMAGE. San José. The upper view shows the wreck of a portion of the plant of the San José Gas Company. The lower view shows the collapse of a large building on the southwest corner of Santa Clara and Third Streets, which had brick walls to the second story level and was built of wood above.

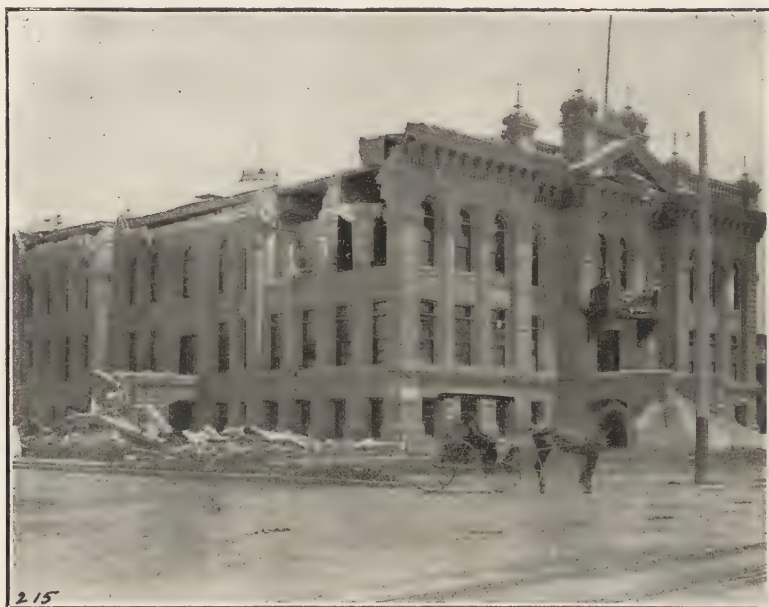
HALL OF JUSTICE. San José. Showing earthquake damage to the parapet walls and overhanging cornices. This damage is characteristic of over 50 per cent. of the business buildings in San José.

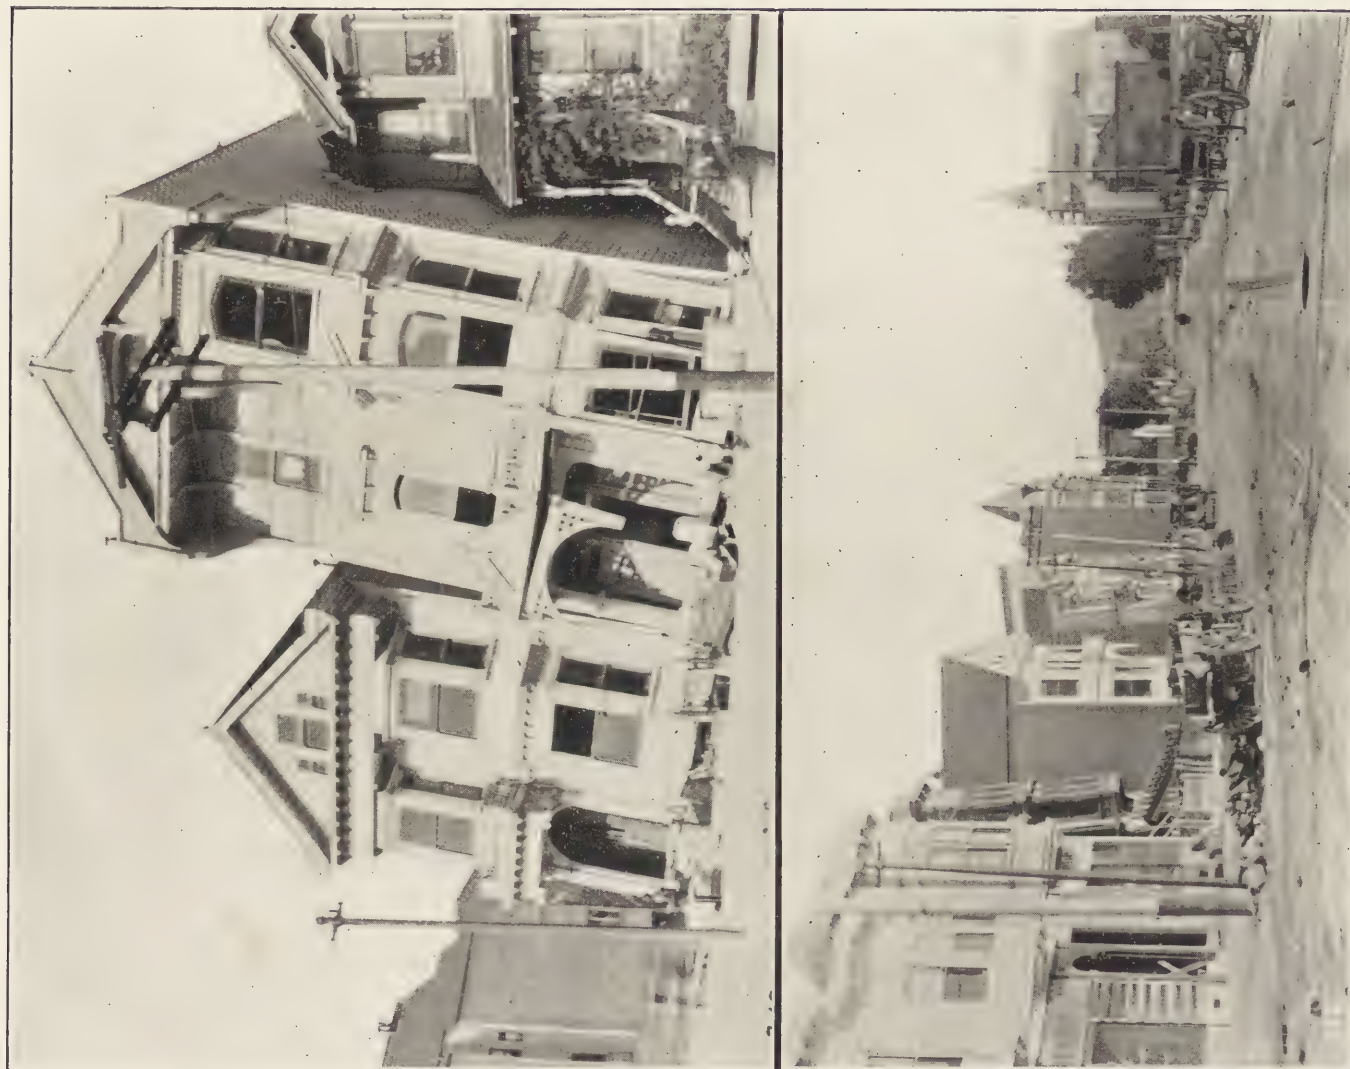
RESIDENCES. Howard Street near Seventeenth Street. The upper view shows two buildings that have been tilted badly out of plumb by the earthquake. The rear portions of the buildings settled about 10 feet. The telegraph poles are approximately plumb. Note the building on the right, the corner of which has broken into the side of the tilted one.

The lower view shows Howard Street, looking west. The front of the two buildings shown in the upper view are approximately in the centre. One building near the left-hand side has tilted away from the street line until it almost disappears.

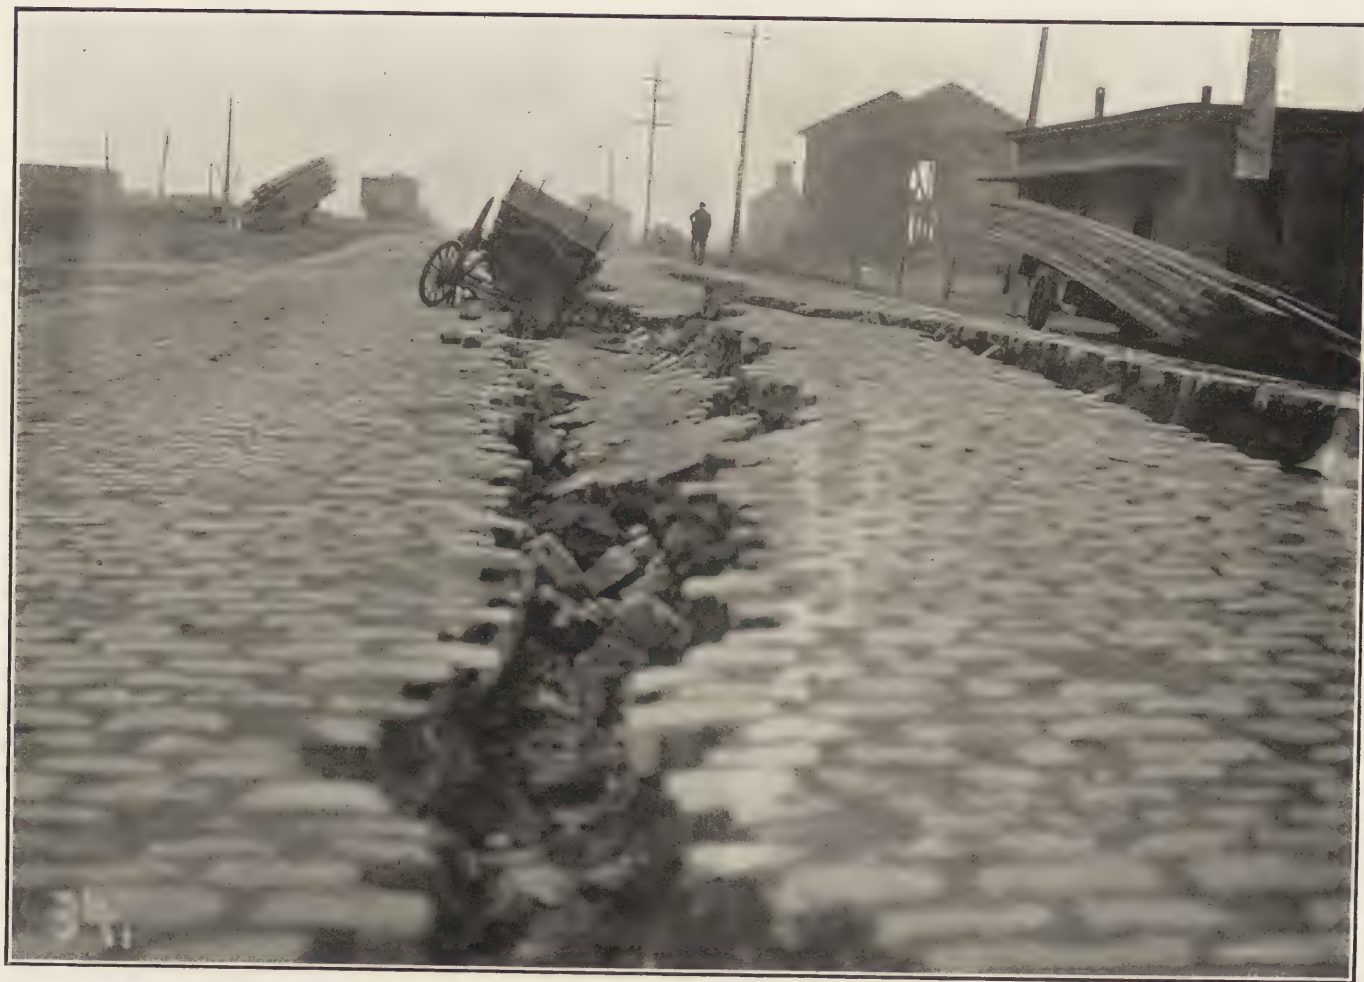
EARTHQUAKE EFFECT. A fissure on East Street near the water front. Note the settlement of the street surface as shown by the exposed curb at the right hand side. In this locality the ground was "made," or artificially filled in.

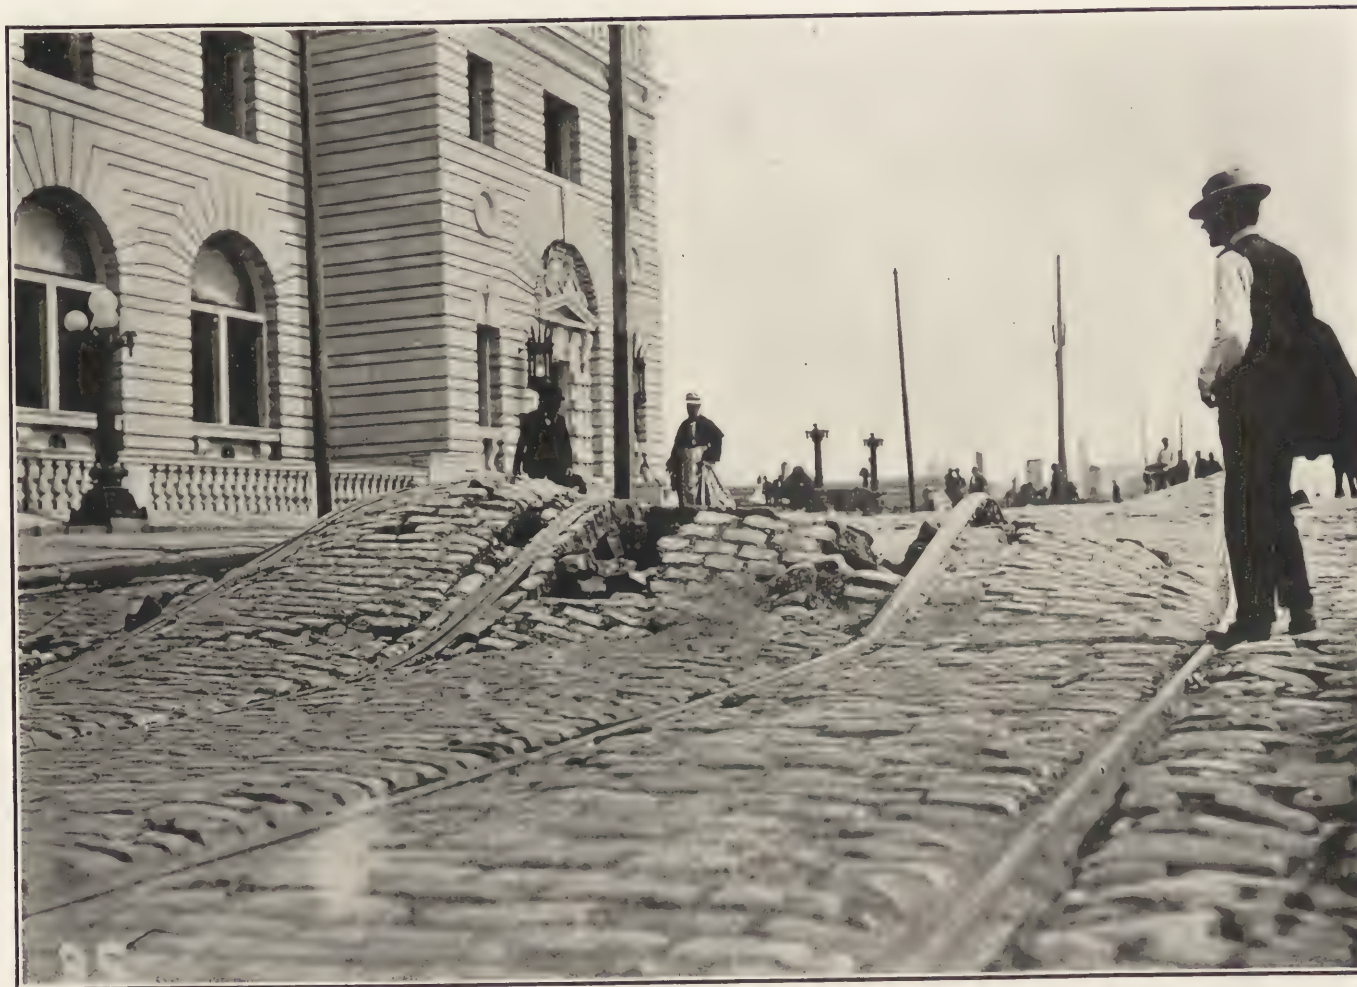
EARTHQUAKE EFFECT. Distortion of the surface of Mission Street near Seventh, showing the southeast corner of the United States Post-Office Building at the left hand side.

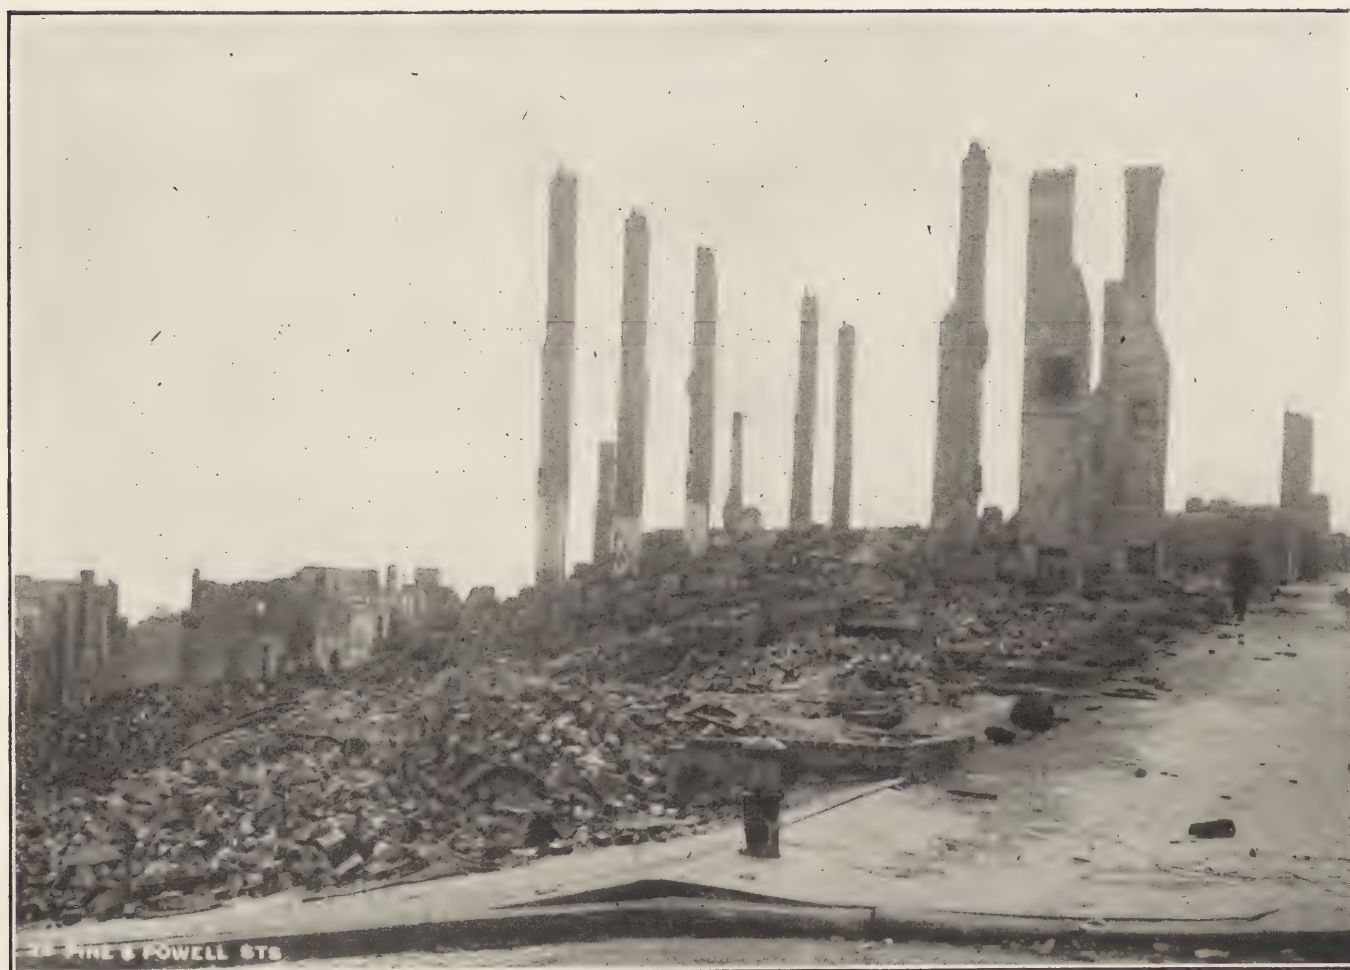
CHIMNEYS. All that remains of many magnificent residences are the chimneys. The top portions of most of these chimneys were shaken off at the roof level by the earthquake before the fire, which accounts for the ragged appearance of the tops. Chimneys of smaller size and poor workmanship were generally overthrown in the fire.

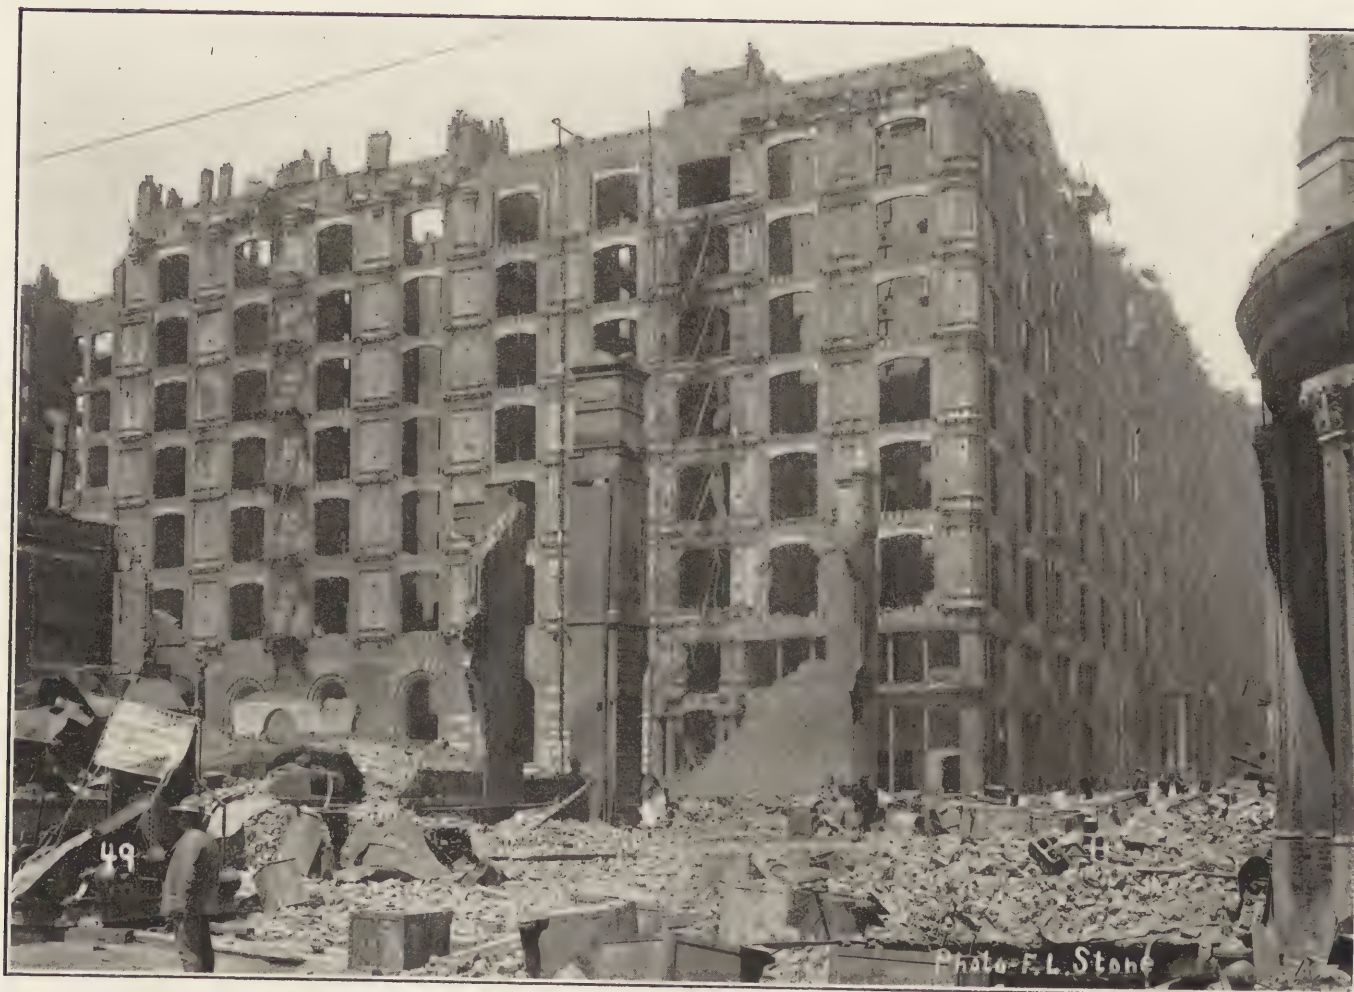
THE PALACE HOTEL. Northwest Corner of Market and New Montgomery Streets. The exterior walls are of brick, well tied by steel rods and bands. The interior dividing walls or partitions are also of brick. The floors and interior finish were of wood. The excellent design and workmanship of the walls prevented any material damage by the earthquake. Fire consumed the wood floors and all the combustible contents, leaving only the walls, which remain in good condition. It is the best preserved building of the non-fire-proof type in the burned district.

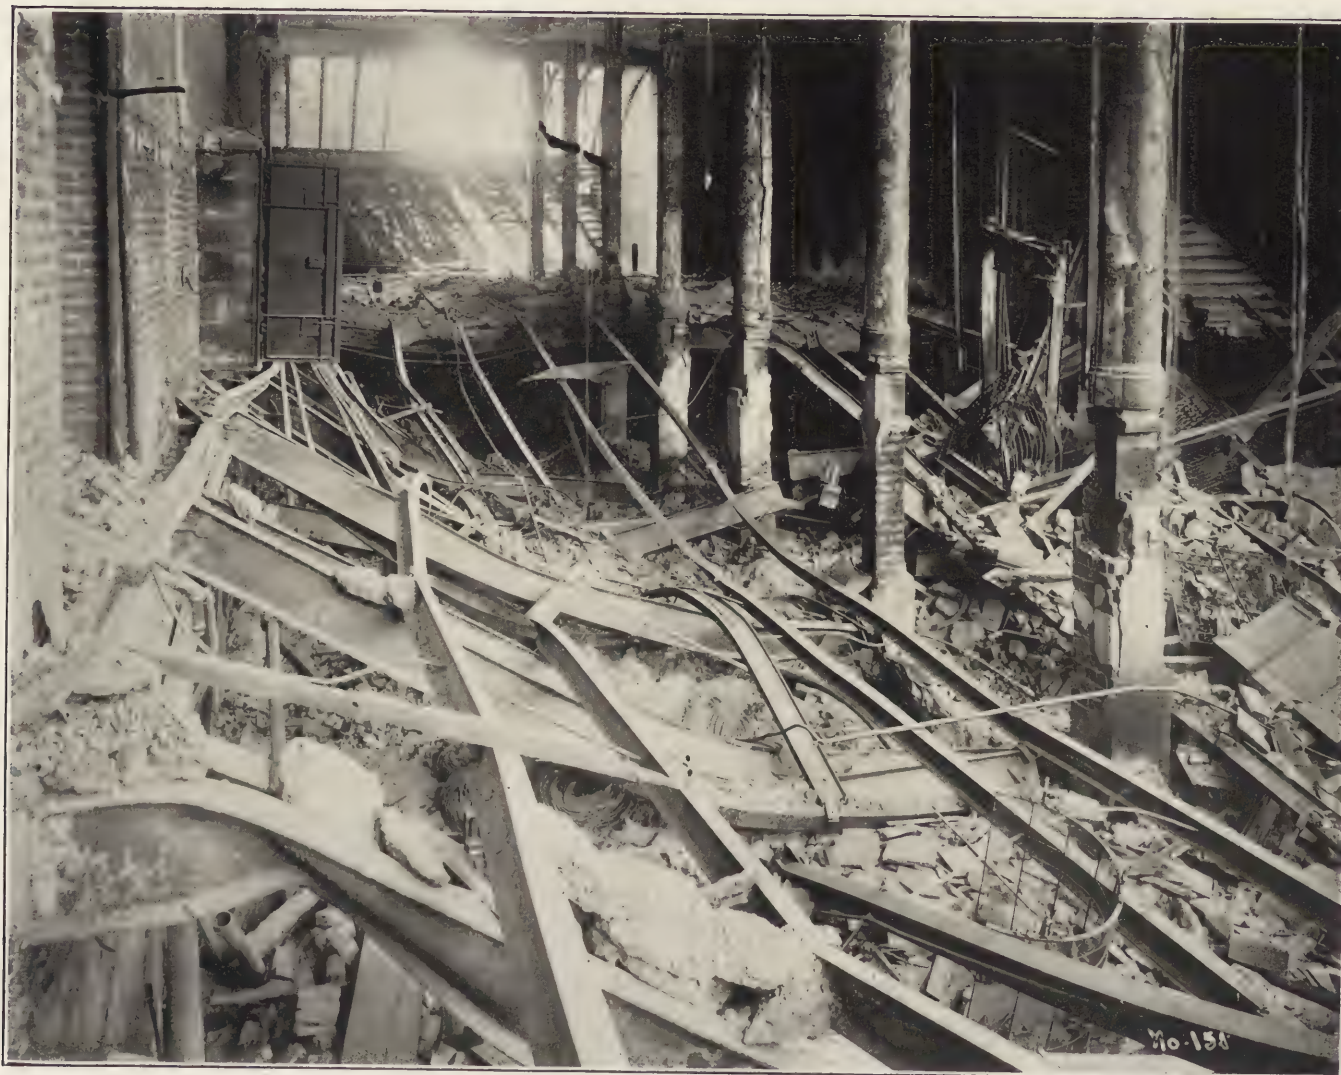
HOBART BUILDING. First floor. View from the sidewalk at the front of the building. A hot fire in the basement caused the excessive deflection of the unprotected girders, which pulled away from the flimsy column connections, permitting the greater portion of the first floor to fall into the basement. The column protection is of metal lath and plaster in the first story, and of hollow tile 2" in thickness in the upper stories.

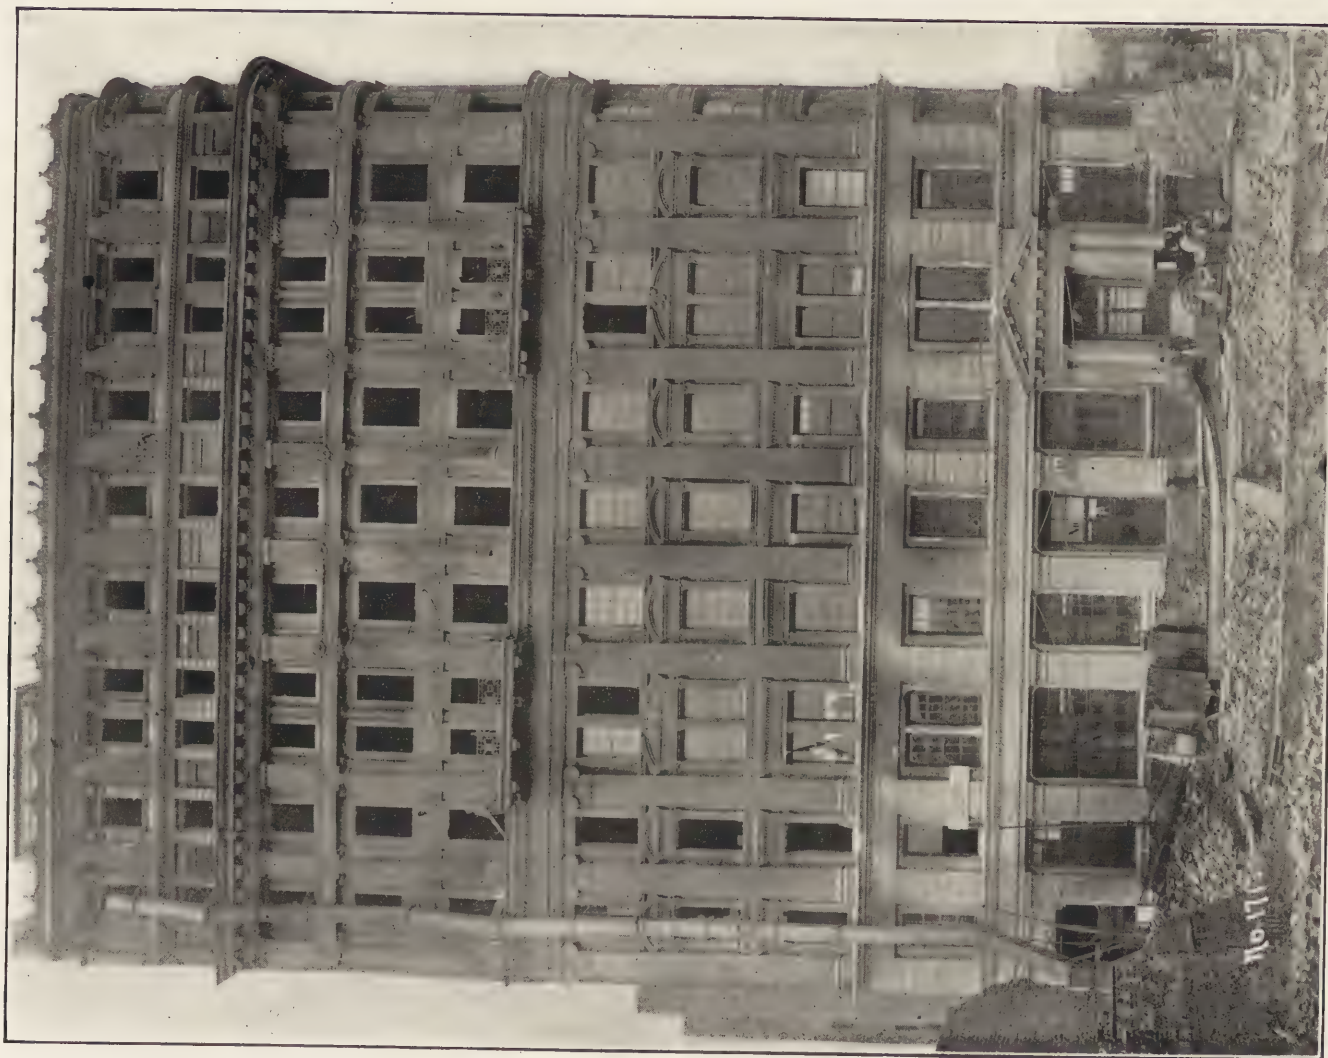
UNION TRUST BUILDING. Northeast Corner Montgomery and Market Streets. The exterior of this building is but slightly damaged, having been exposed to only a moderate fire. The granite of the first and second stories is spalled around the window openings, the greatest damage having been wrought on the Montgomery Street side. The principal structural damage to this building was caused by the failure of a hollow tile suspended ceiling which admitted the flames to the blind space between the ceiling and the roof, causing the injurious deflection of a large portion of the roof framing. The hollow tile floor arches throughout are in fair condition. The soffits have fallen away in numerous cases, exposing the cellular spaces, and a few spans between beams have been broken down by falling safes. The hollow tile partitions are badly damaged, and a large proportion has fallen down. The hollow tile column covering is off in many places, exposing the columns, the piping within the protection being responsible for much of the damage.

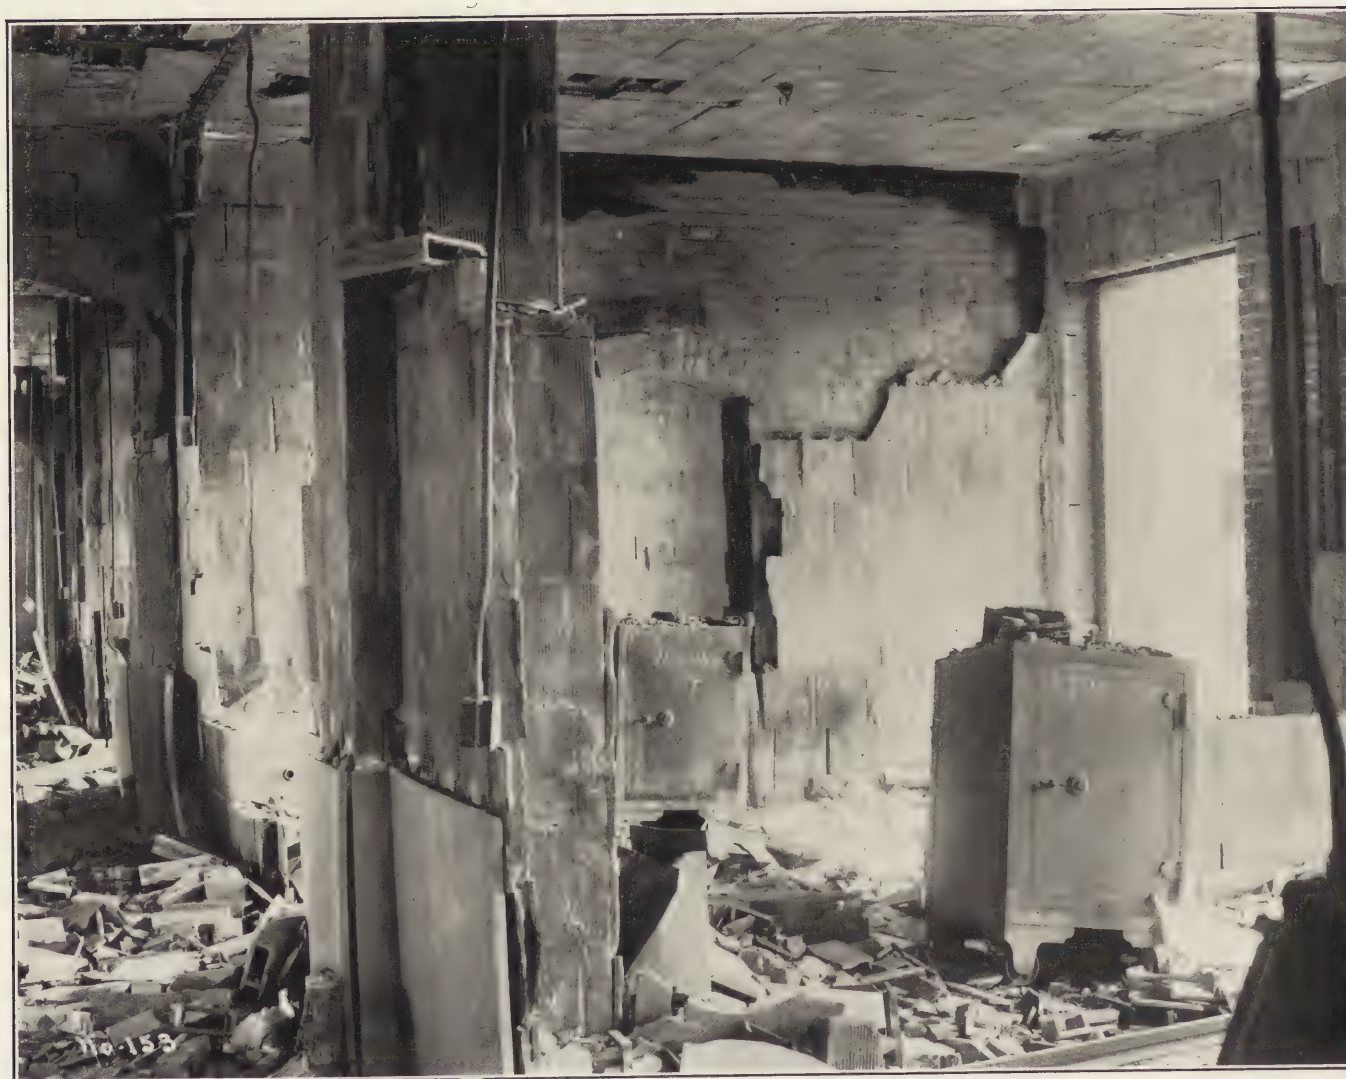
UNION TRUST BUILDING. Seventh Story. Typical view of the damage to the hollow tile floors, partitions, column covering, and wall furring. The safe in the foreground has been moved to a secure position over a girder. The safe in the centre has been moved into the doorway through the party wall between the old and the new parts of the building.

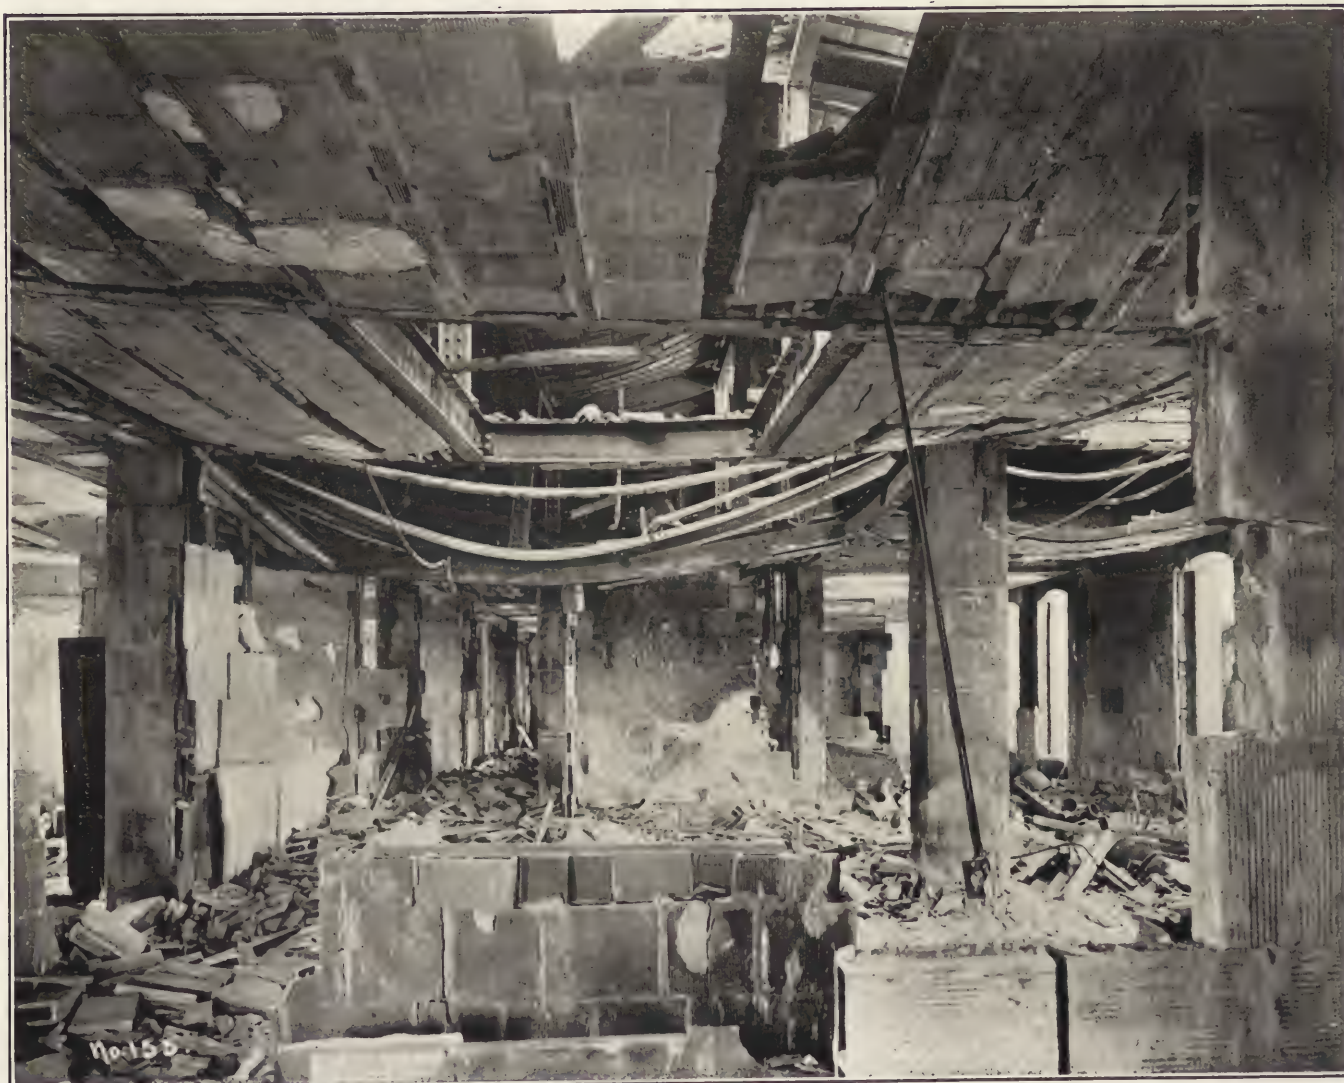
UNION TRUST BUILDING. Top Story. Showing the deflected steel work of the roof and hung ceiling, also the damage to the hollow tile partitions, column covering, and the book tiles of the hung ceiling. The steel work supporting the ceiling was unusually heavy. When the hung ceiling failed, the fire greatly damaged the steel work of the roof construction, causing it to deflect badly. See also a different view of the same story on the opposite page.

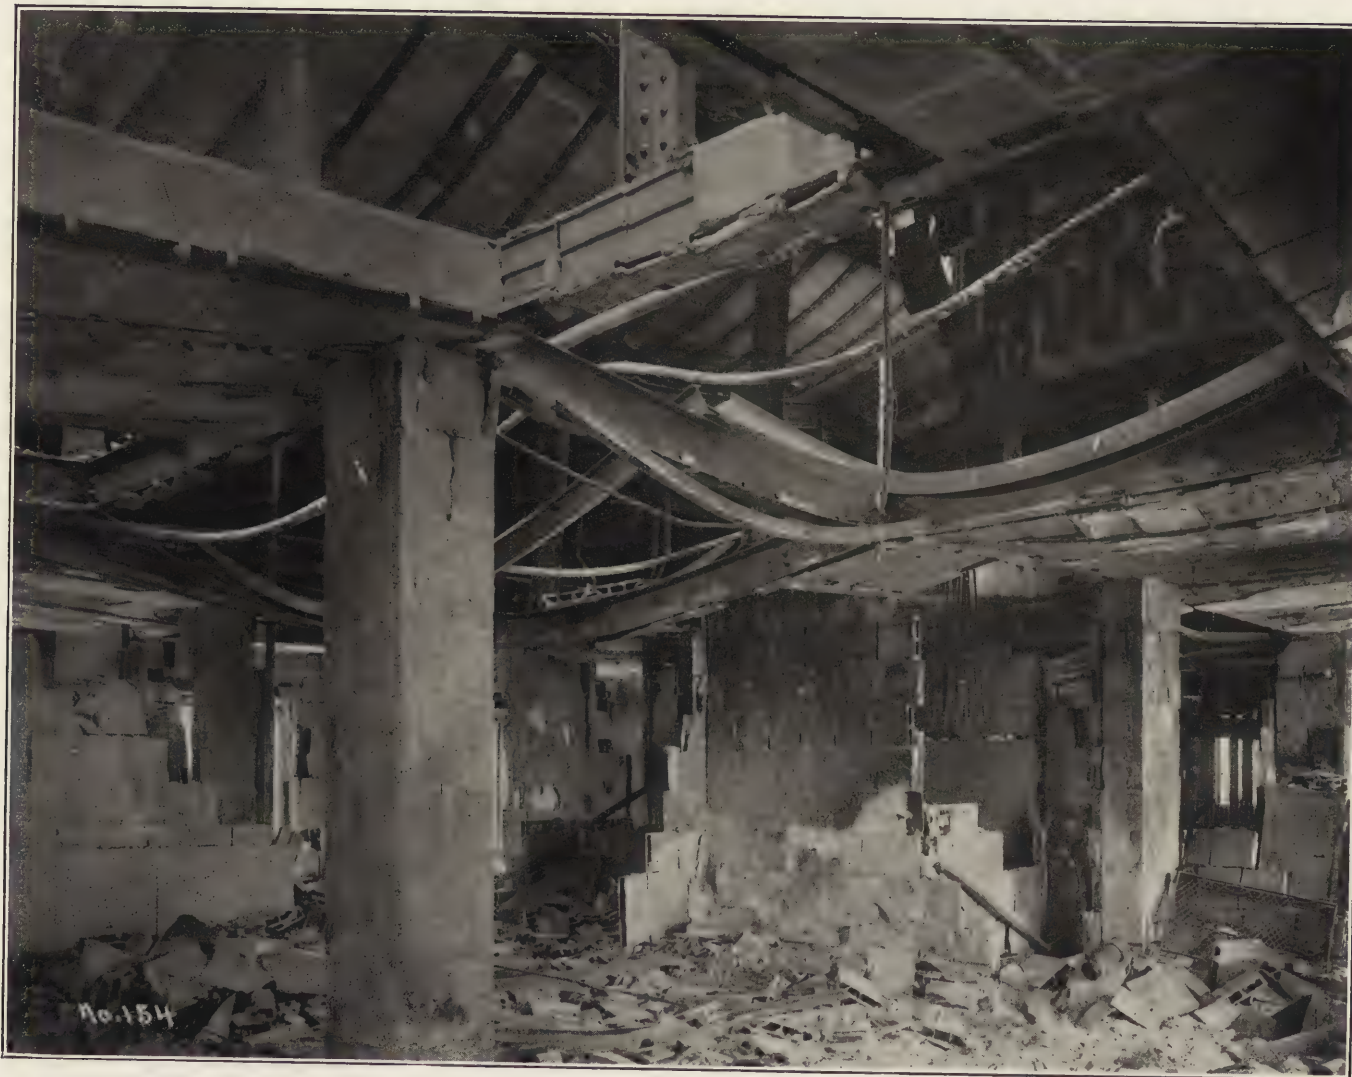
UNION TRUST BUILDING. Top Story. Showing the failure of the heavy steel work supporting the hung ceiling, and the damage to the steel framing of the roof. Showing also the condition of the hollow tile column covering and partitions. The additional fuel of an attorney's library is responsible for this damage.

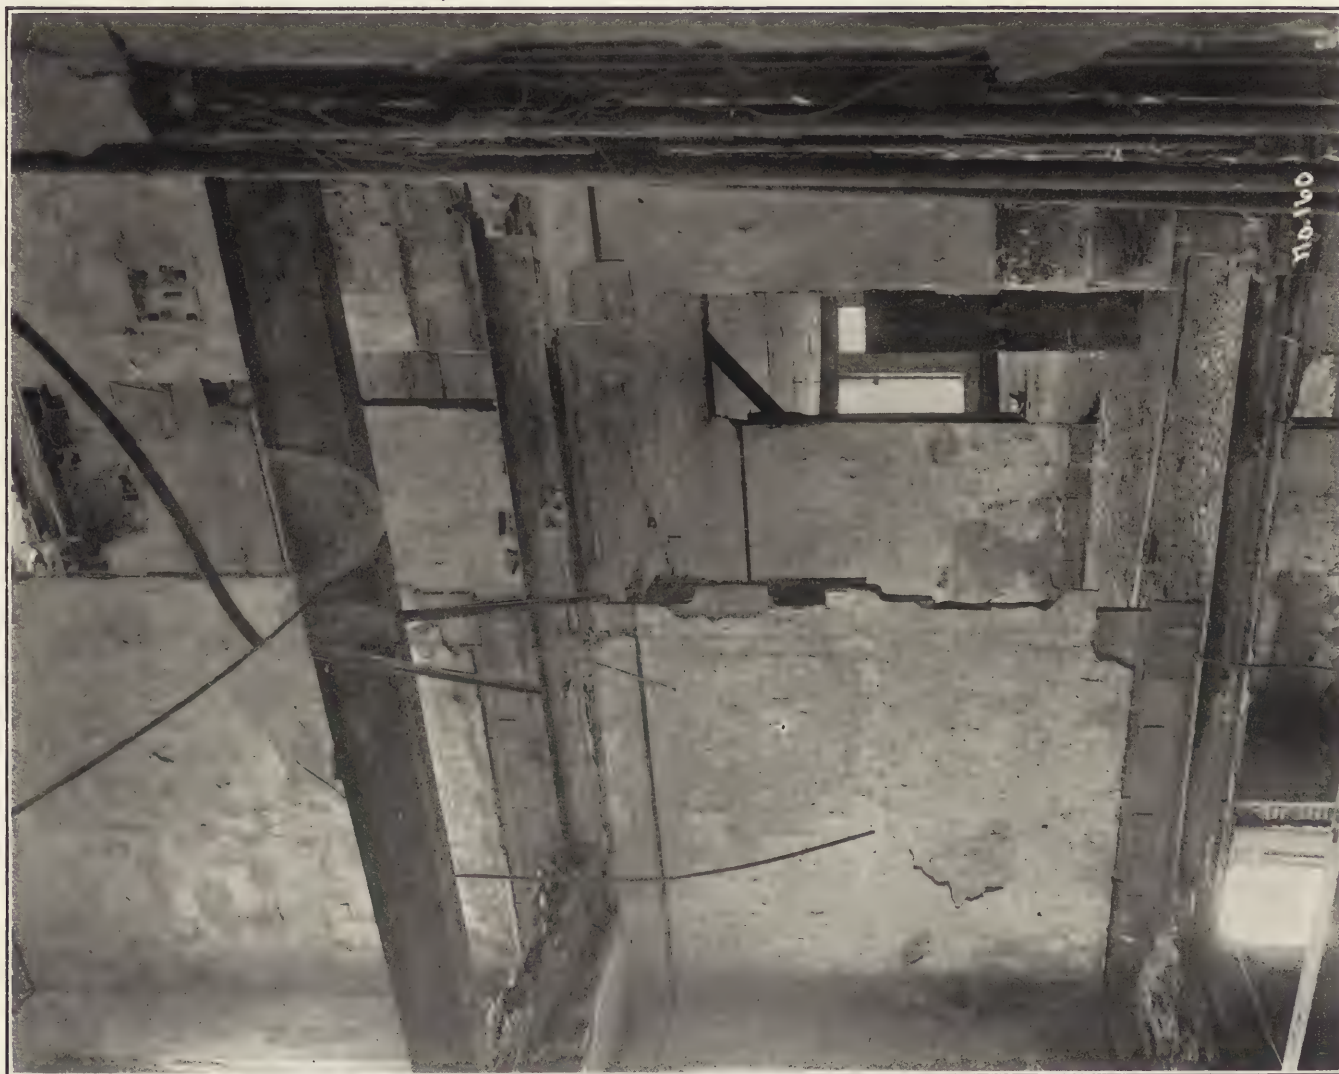
The floor arches are in fair condition. There are many places where the soffits of the tile blocks have fallen away, exposing the cellular spaces. The partitions are badly damaged throughout, a large proportion of the blocks having fallen down. Safes also caused the failure of some of the floor arches in this building.

MUTUAL LIFE BUILDING. Fifth Story. Showing the openings through the fifth and sixth floors where the hollow tile arches were broken out by a falling safe. The broken tie rods are still hanging from the beams. The pipes on the right hand side were enclosed within the hollow tile column protection, and no doubt contributed toward its failure.

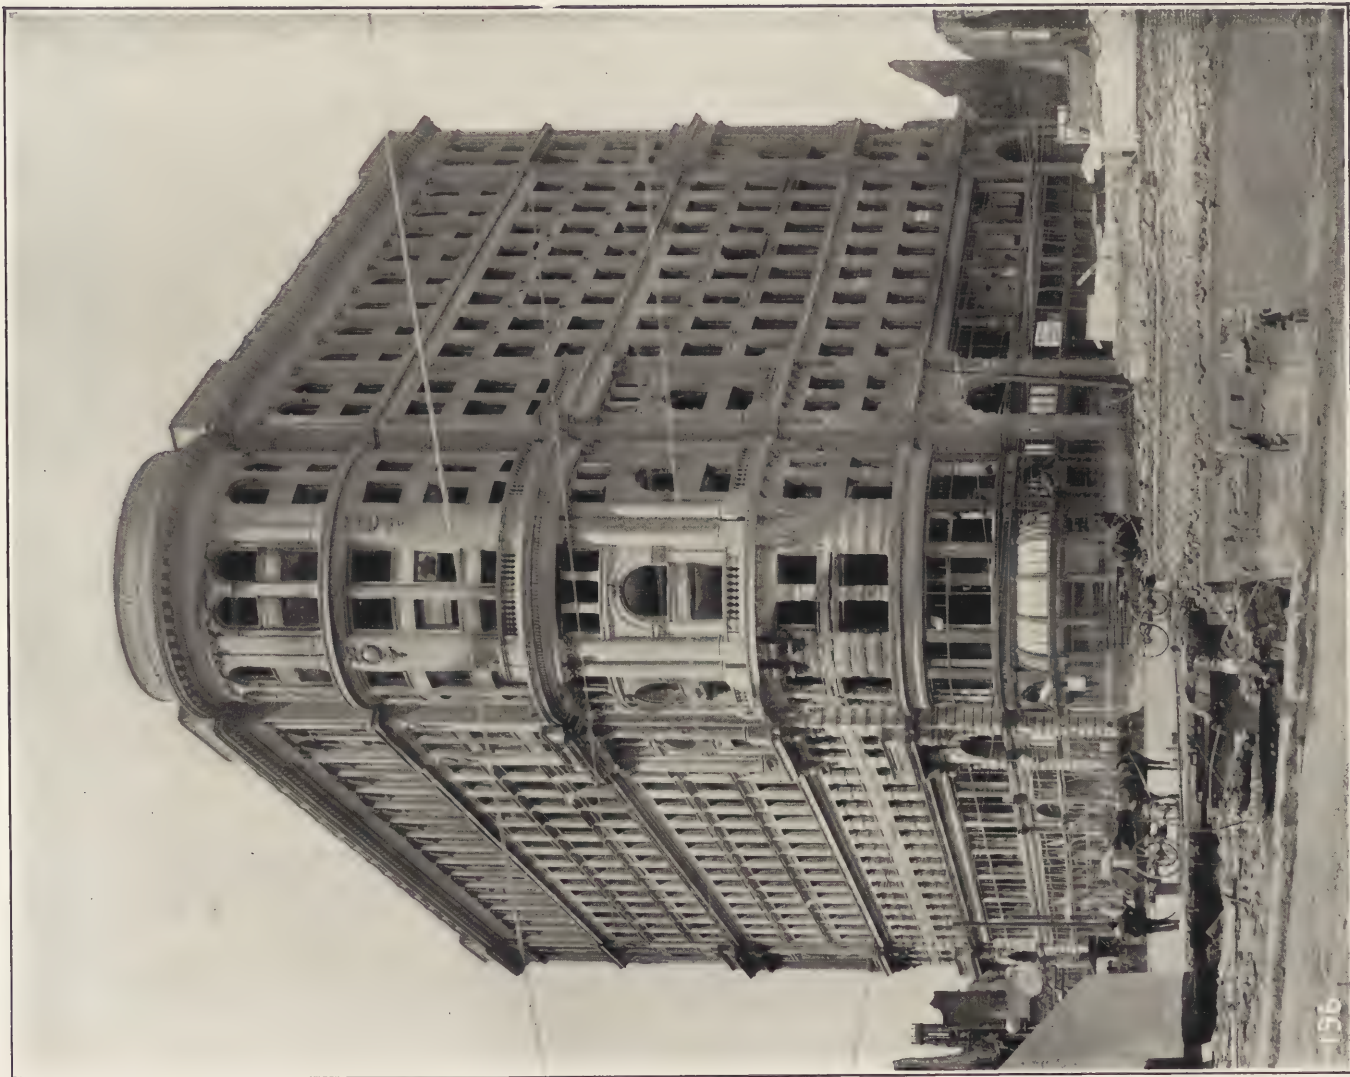
JAMES FLOOD BUILDING. Powell and Market Streets. The façades are of Colusa sandstone, with a pink granite base to the water table. The damage to the exterior consists of spalling around a number of the window openings and earthquake cracks where the corner tower joins the side walls, and at the northwest corner pier of the Powell Street side at the first-story level. The fire-proof floors are of hollow tile arches, segmental in form, with Rocking flat wire lath and plastered ceilings underneath. The column protection, partitions and wall furring consist of hollow tile blocks. The floors are in good condition, except a section over the central portion in the first story. A fire of greater intensity occurred in this location, causing the failure of the wire lath ceiling. When the latter fell away, the hollow tile blocks above it were damaged by the fire, exposing the cellular spaces over a considerable area. The hollow tile partitions stood as well in this building as in any in the burned district, but about 15 per cent. of the partition areas are down. The hollow tile column protection was badly damaged in many places, but fulfilled its purpose and prevented the failure of the columns.

The Market Street front is slightly spalled around the window openings, and is but little damaged by the fire. The

window openings are also considerably spalled in places on the Powell Street side, those on the west side at the fifth and sixth stories being injured most. Where the semi-circular tower joins the Market and Powell Street walls, both sides are considerably cracked by the earthquake. The northwest corner pier of the Powell Street side is also racked and shattered by the earthquake. The east half of the Ellis Street front is very badly scaled and spalled. The northeast corner is greatly damaged by the earthquake. The east gable wall of brick is in good condition.

The levels on the water table indicate that the foundations remain level and intact. Observations on the different corners of the building show that the walls remain perfectly plumb. The steel skeleton frame is uninjured.
